RESEARCH AND EDUCATIONAL ACTIVITIES AT THE FAST CENTER FOR STRUCTURAL INTEGRITY OF AEROSPACE SYSTEMS

A Final Report

Grant No. F49620-95-1-0518

FAST Center for Structural Integrity of Aerospace Systems

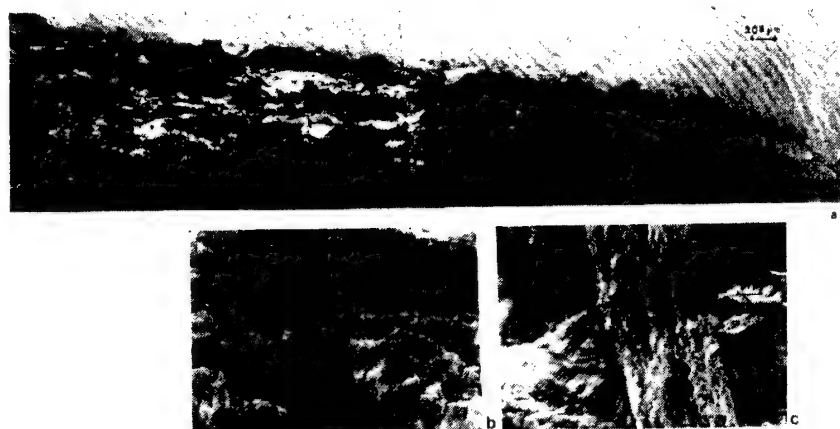
Figure 4.14 Scanning electron micrograph of the exfoliated 2024 aluminum body skin section shown in Fig. 4.11. The right-hand part of (a) is near the edge of a rivet hole. Insets (b) and (c) show magnified views of specific areas exhibiting heavy corrosion products.

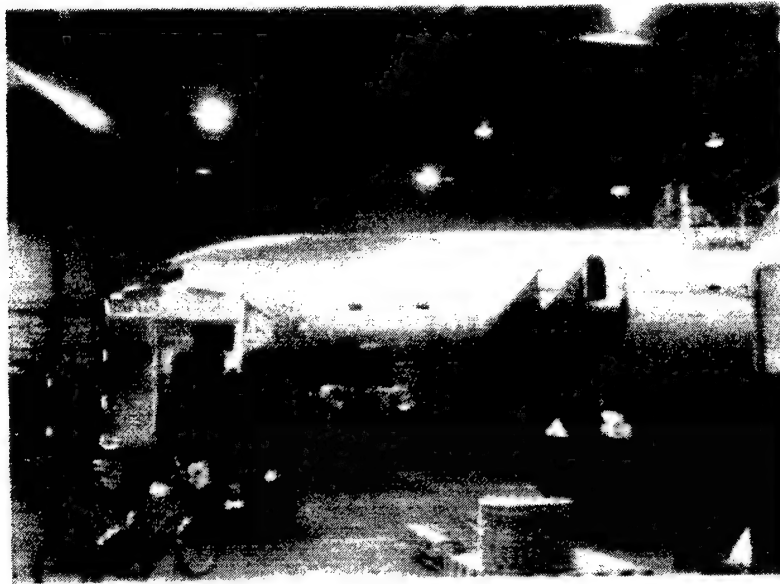
Figure 4.17 KC-135 fuel tanker at its Programmed Depot Maintenance (PDM) at Tinker Air Force Base. The paint has been removed.

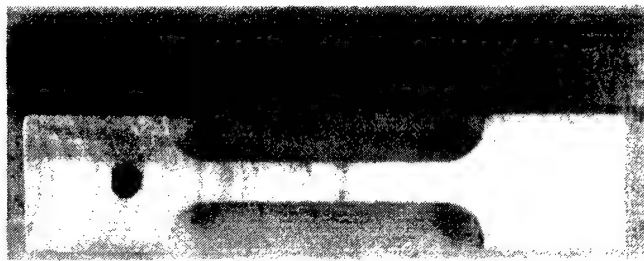
Figure 4.20 Sample of a test specimen used for tensile testing, the thickness is approximately 0.25 inches.
